Kathmandu, Nepal **DISASTER RELIEF PROJECT**

Monthly Report - September and October 2015

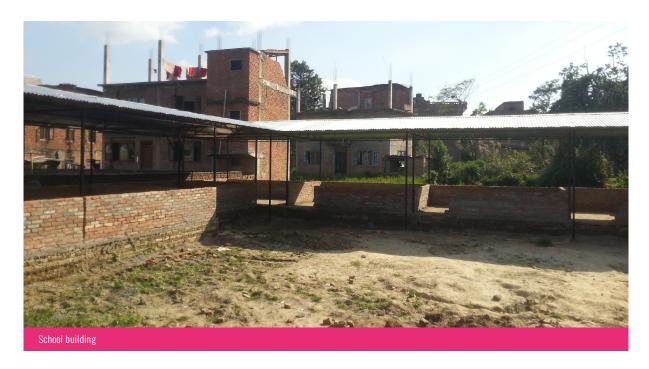
The footings were created in three layers; the first consisting of eighteen inch brickwork, requiring courses to contain two rows of headers and four rows of stretcher bonds. After three courses of this eighteen inch brickwork, three courses of fourteen inch brickwork were constructed. A final 3 courses of 9 inch brick work was installed to provide sufficient strength to the footings and provide a stable base for the construction of the future classroom walls.

The construction of the footings required all volunteers to mix hundreds of kilograms of concrete and transport many bricks, which was completed with great cooperation and enthusiasm. Finalising the construction of the footings required retained soil to be used to fill existing space within the trenches and then compacted by volunteers.
